Appendix F

Waters Report

US 224 over Holthouse Ditch Bridge Project in Adams County, Indiana

Des. No. 1701394

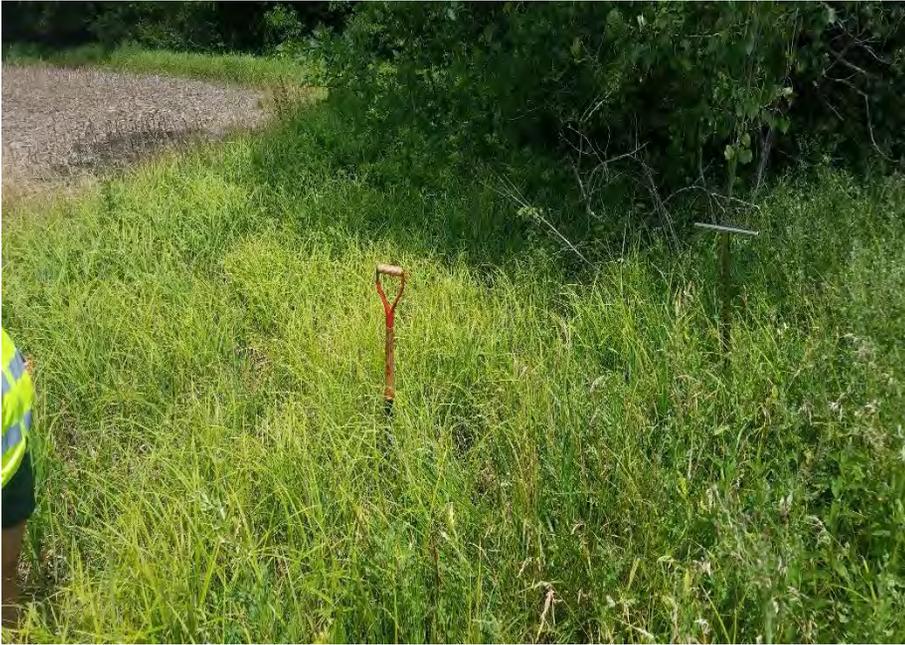
Photo 5. Sample Point 1 Facing Northeast

Sample Point 1 (SP1) was taken in the northwest quadrant of the bridge. This site was not mapped as a wetland on the attached NWI map. Vegetation at this sample point was dominated by Cottonwood (*Populus deltoides*, FAC), Green Ash (*Fraxinus pennsylvanica*, FACW), and Eastern Narrow-Leaf Sedge (*Carex amphibola*, FAC). This vegetation community passed the dominance test and prevalence index for hydrophytic vegetation. Hydrology indicators at SP1 included Geomorphic Position (D2) and FAC-Neutral Test (D5). Soils at SP1 were 10 YR 4/2 (100%) from 0-11 inches with a texture of clay loam. From 11-16 inches, the soil was 10 YR 4/2 (90%) with

redox concentrations of 10 YR 5/4 (10%) with a texture of clay loam. This does not meet any criteria for hydric soils. SP1 met the criteria for hydrophytic vegetation and wetland hydrology but did not meet the criteria for hydric soils; therefore, it is not within a wetland.

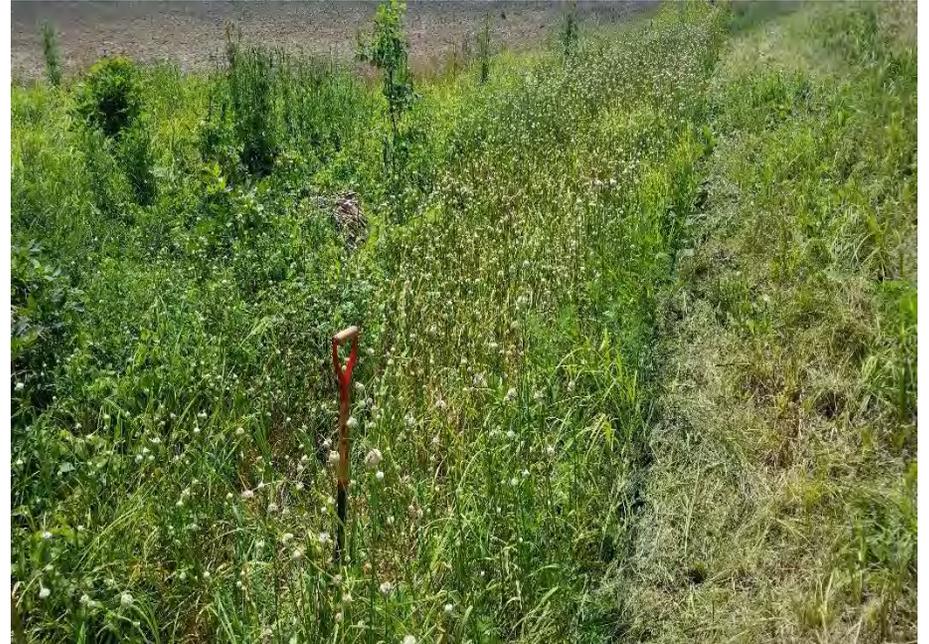
Photo 8. Sample Point 2 Facing Southwest

Sample Point 2 (SP2) was taken in the southwest quadrant of the bridge. Vegetation at this sample point was dominated by Meadow Garlic (*Allium canadense*, FACU) and Eastern Narrow-Leaf Sedge (*Carex amphibola*, FAC). This vegetation community did not pass the rapid test, dominance test, or prevalence index for hydrophytic vegetation. Hydrology indicators present at SP2 included Geomorphic Position (D2). Wetland hydrology was not present at SP2. Soils at SP2 were 10 YR 3/2 (100%) from 0-10 inches with a texture of loam, and 10 YR 3/2 (90%) with redox concentrations of 10 YR 5/4 (10%) from 10-16 inches with a texture of loam. This does not meet any criteria for hydric soils. SP2 did not exhibit hydrophytic vegetation, hydric soils, or wetland hydrology; therefore, it was not within a wetland.

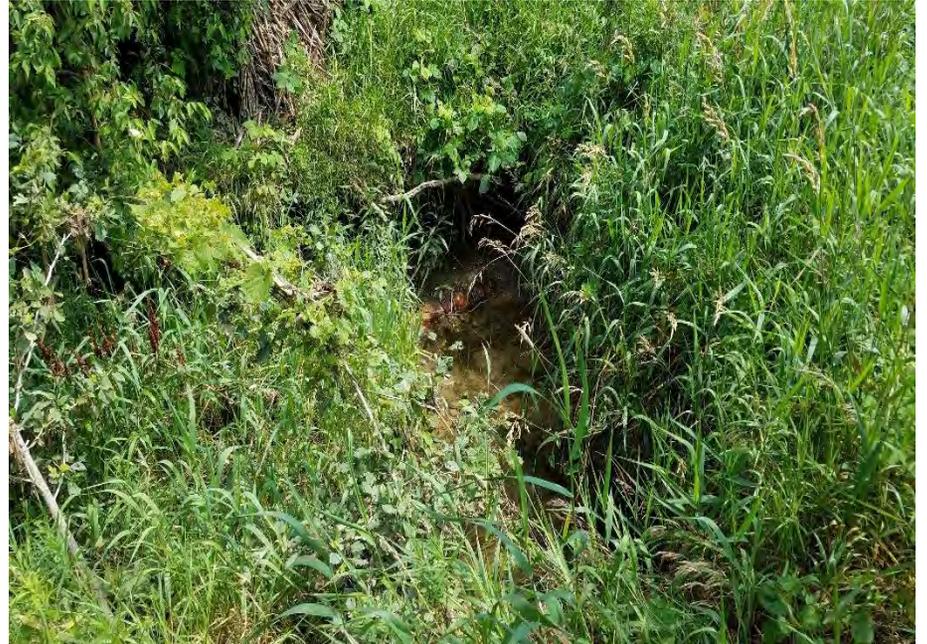
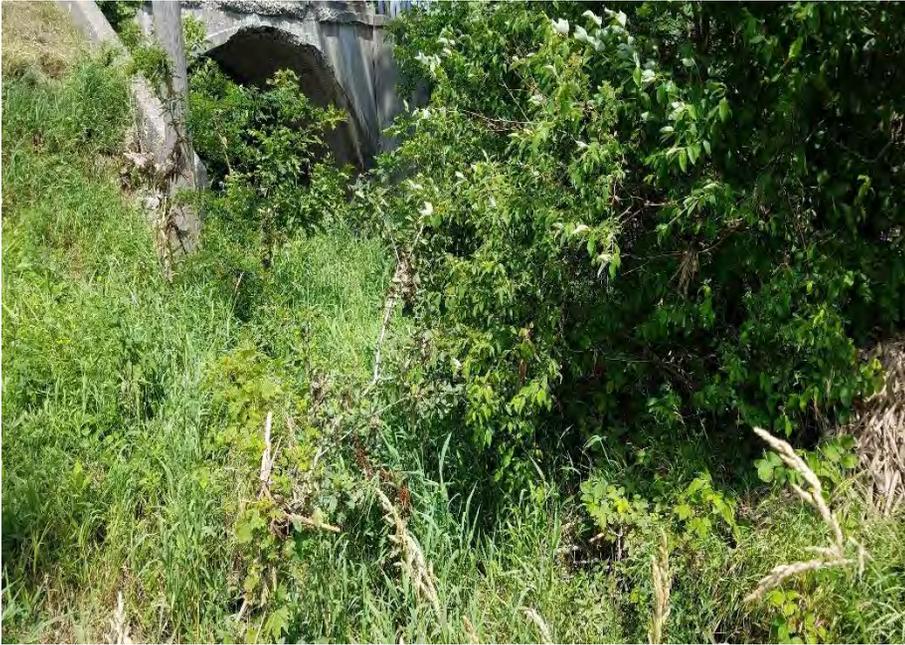
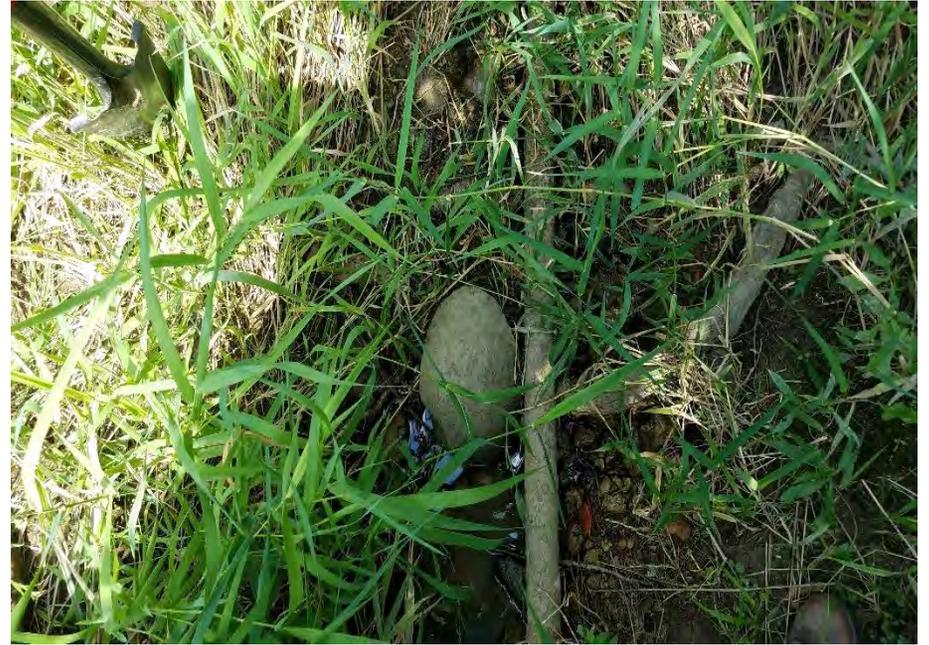
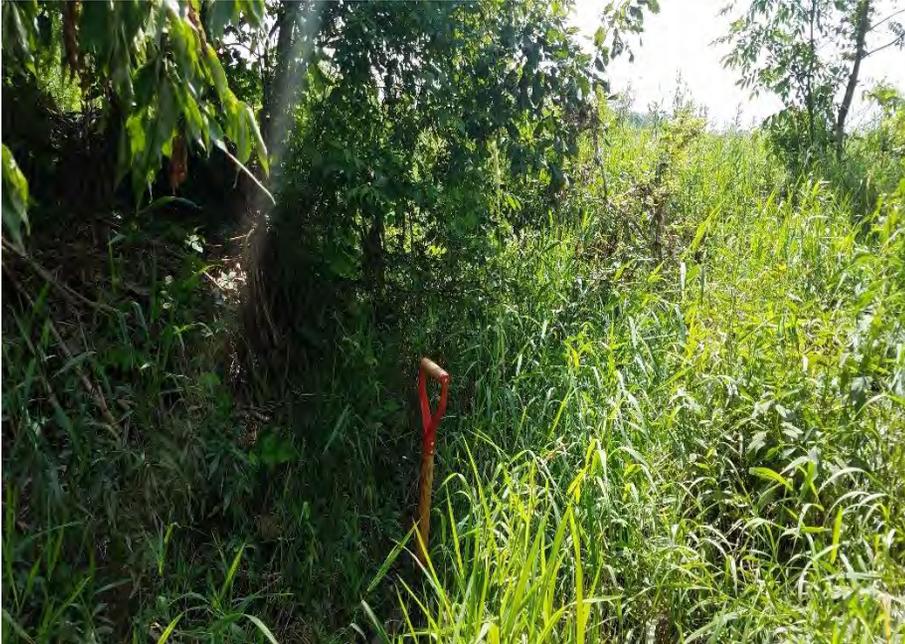
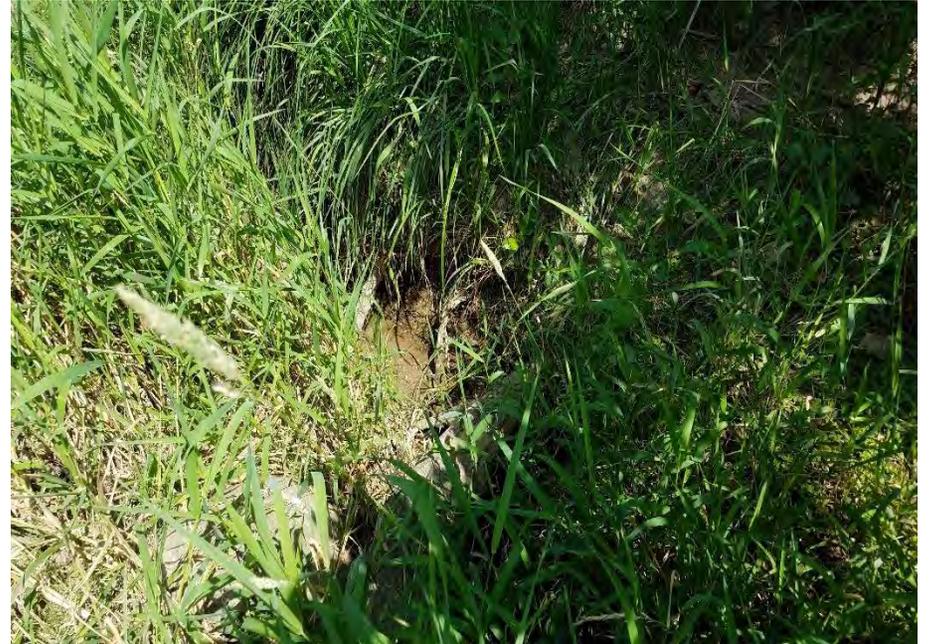
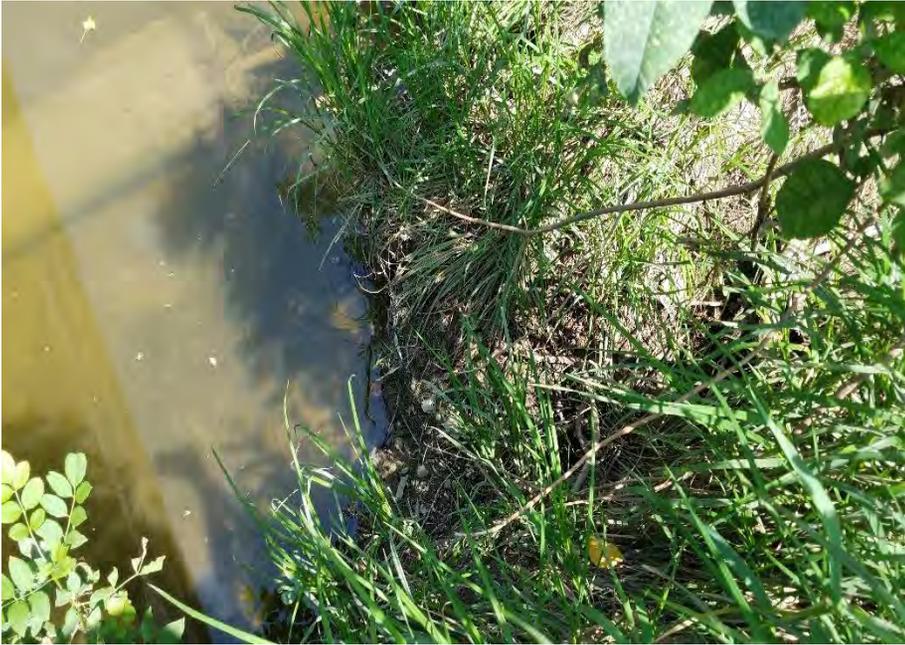
UNT 1 is an ephemeral stream in the southwest quadrant of the bridge that conveys drainage from west to east towards Holthouse Ditch. UNT 1 is not mapped on the attached NWI map but would have a Cowardin Classification of R4UBHx (Riverine, ephemeral, unconsolidated bottom, excavated). A review of the US Geological Survey (USGS) *Streamstats* application did not show UNT 1. It is not mapped on the attached topographic map. UNT 1 exhibited an OHWM width of 8 inches and depth of 2 inches. This stream is considered poor quality because it has a substrate of silt, provides no in-stream cover, exhibits low sinuosity, and does not provide riffle and run complexes. This feature is likely jurisdictional under the authority of the USACE because it exhibits an OHWM and drains into Holthouse Ditch, which is a likely jurisdictional water feature. UNT 1 is shown in photos 12 through 17 in the attached photo log.

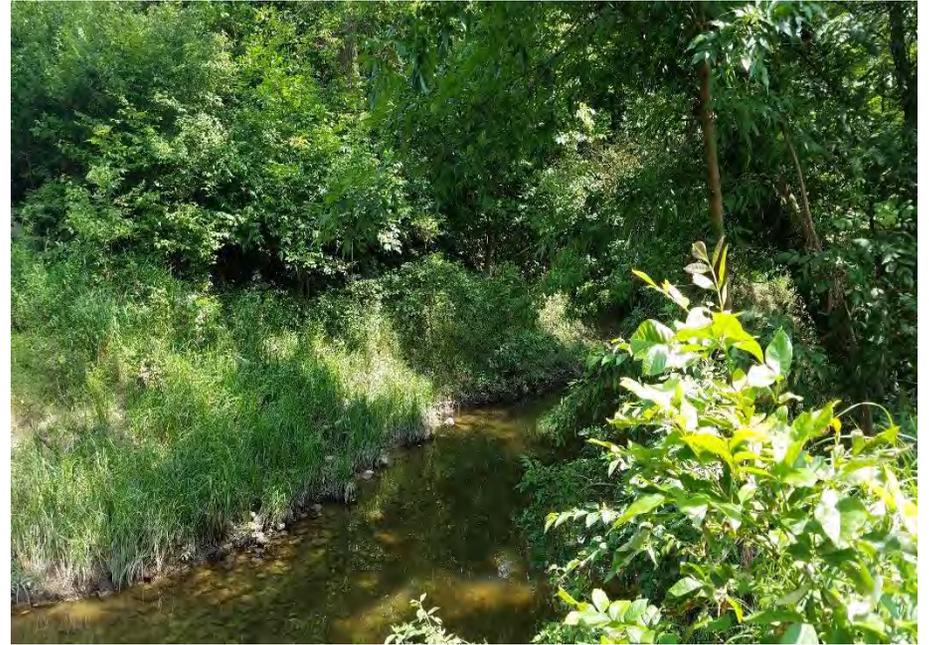
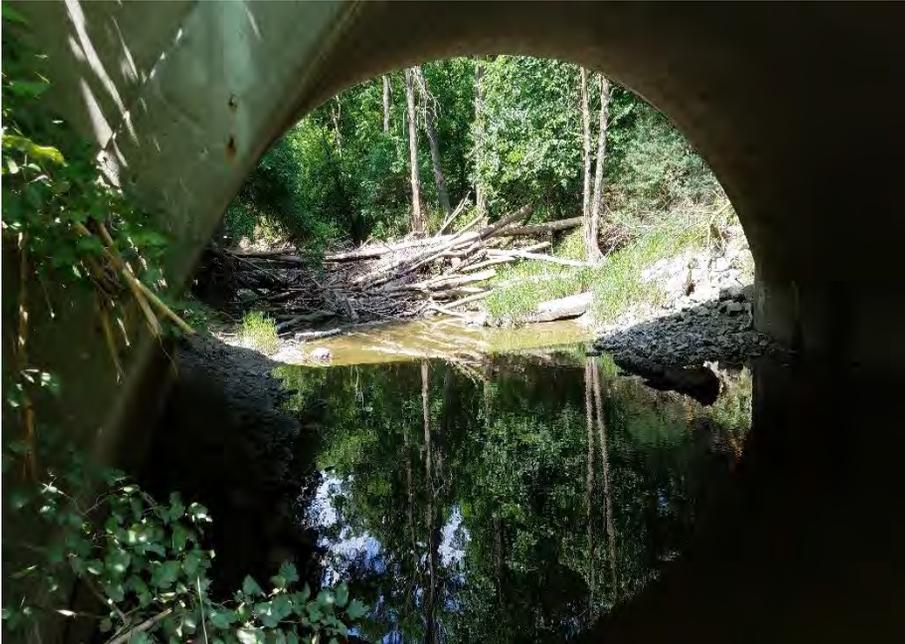
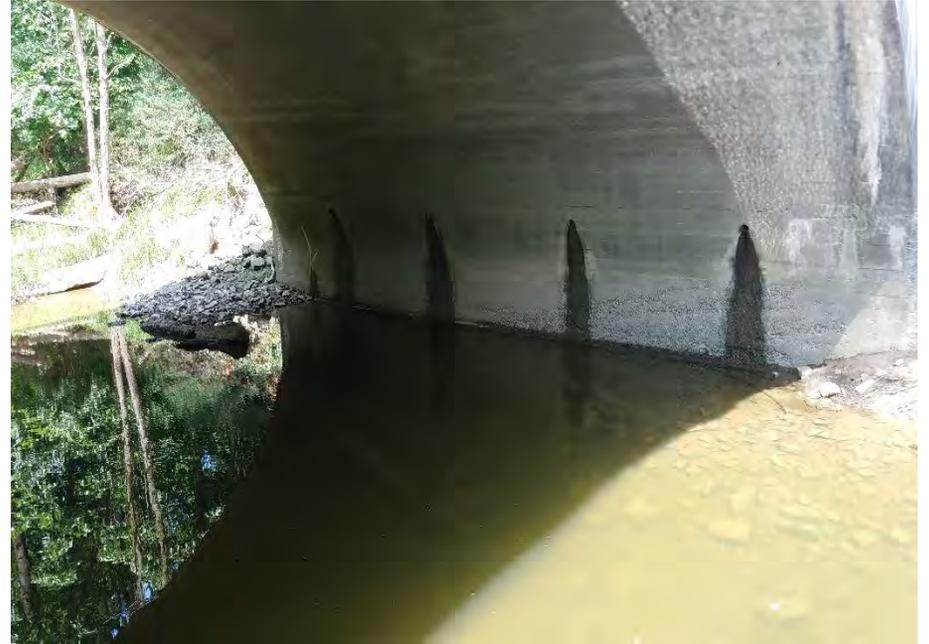
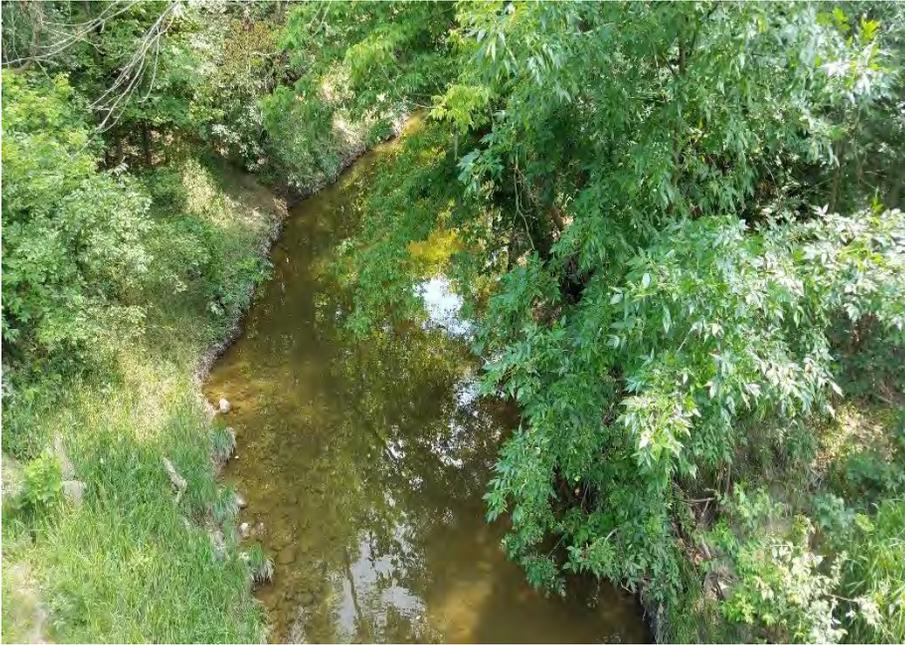
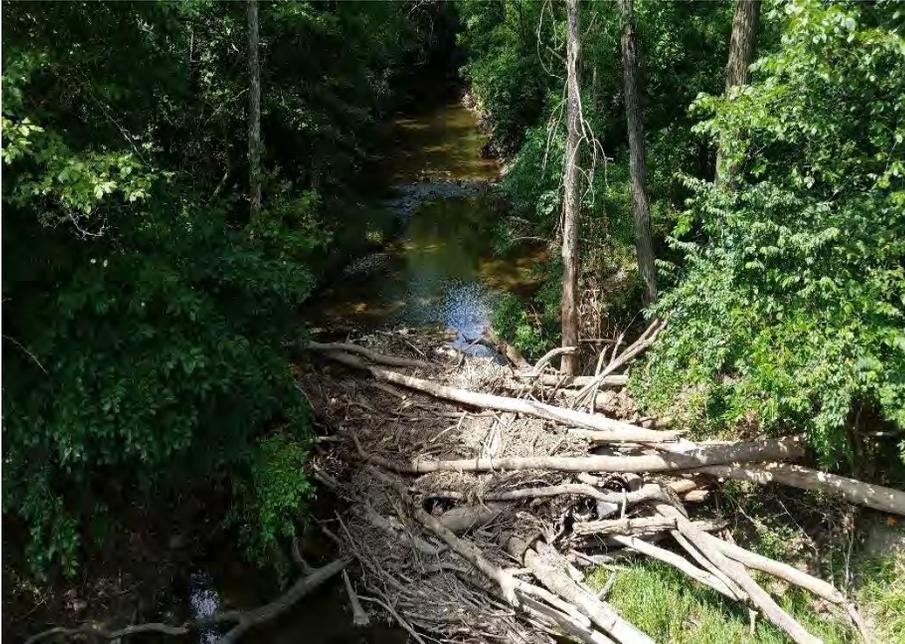
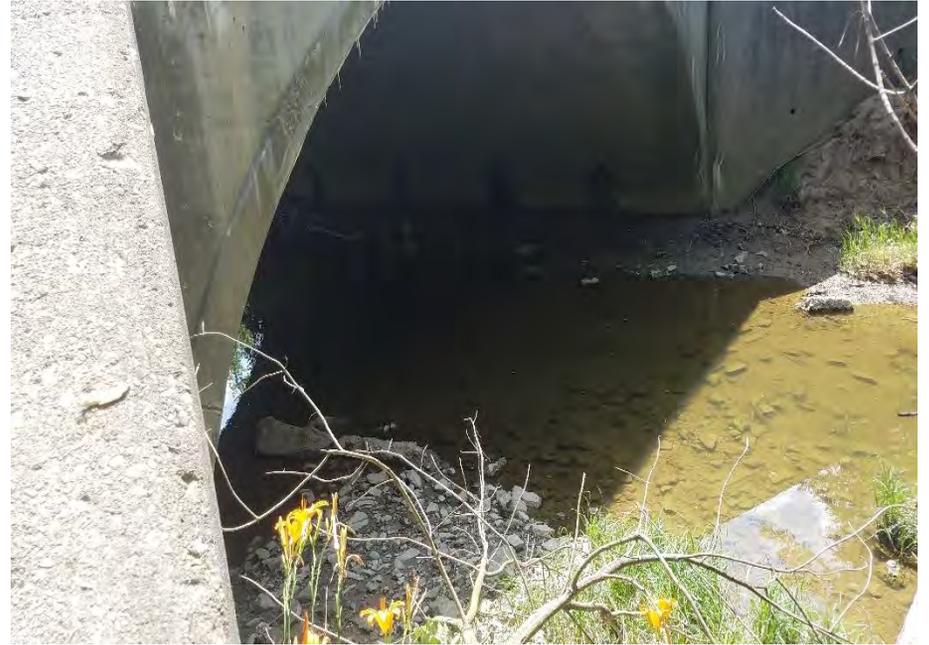
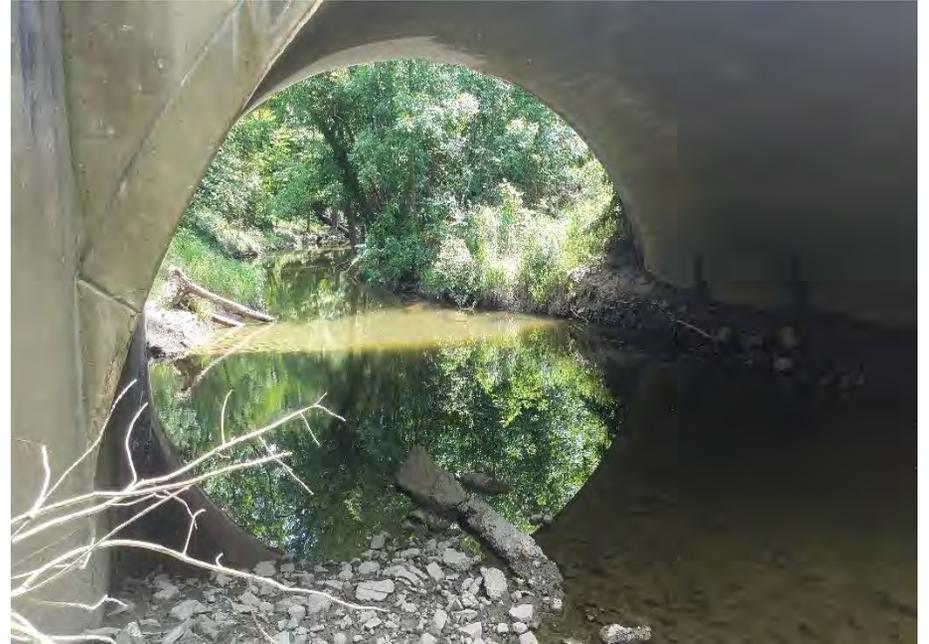
Holthouse Ditch is a perennial stream that conveys drainage from south to north through the project bridge. Holthouse Ditch is mapped on the attached NWI map as PFO1A (Palustrine, forested, seasonally flooded), but it more closely resembles R2UBH (Riverine, perennial, permanently flooded). A review of the US Geological Survey (USGS) *Streamstats* application indicated that Holthouse Ditch had an upstream drainage area of 29.266 square miles. It is mapped as a solid blue-line stream on the attached topographic map. Holthouse Ditch exhibited an OHWM width of 25 feet and depth of 3 feet. This measurement was taken on the upstream side of the project bridge to avoid influence from the drainage structure. This stream is considered average quality because it has a substrate of silt, provides moderate in-stream cover, exhibits low sinuosity, provides riffle and run complexes, and provides moderate habitat for aquatic fauna. This feature is likely jurisdictional under the authority of the USACE because it exhibits an OHWM, relatively permanent flow patterns, and eventual connectivity to Lake Erie. Lake Erie is a Traditionally Navigable Waterway. Holthouse Ditch is shown in photos 18 through 25 in the attached photo log.

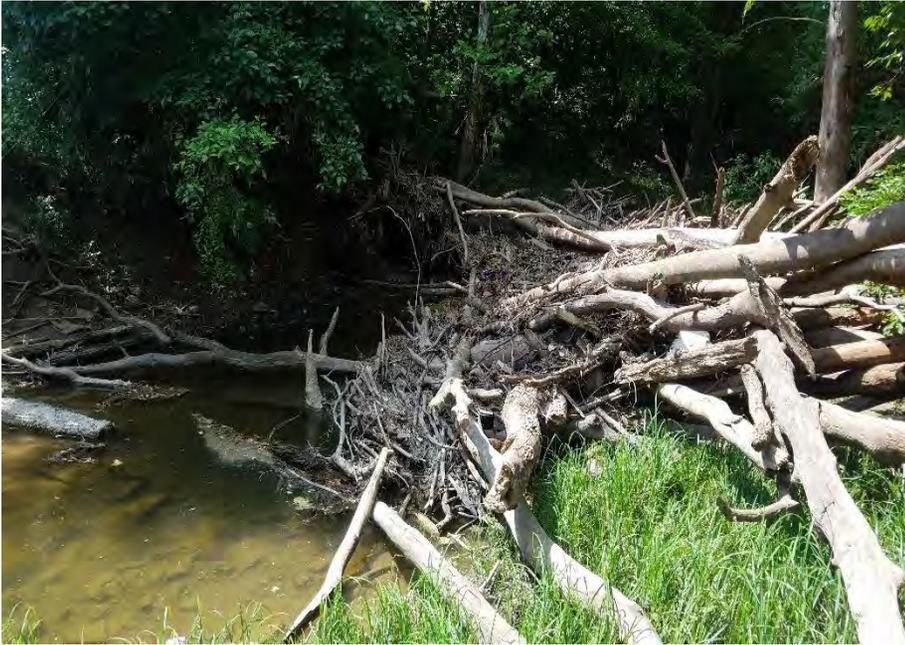
Photo 25. Debris in Holthouse Ditch North of Project Bridge Facing Northwest

The subject structure was last inspected in 6/22/2018. The inspection report, shown in Attachment D, indicates an existing superstructure condition rating of fair (5) due to the age and heavy deterioration in top of arch ring and both head walls. The decorative caps on both walls are disintegrating. Cracking and spalling is present. The existing substructure condition rating is fair (5) due to age and disintegration of two wings of the abutments. No hard deck exists as HMA is carried over the structure over shallow fill. The wearing surface condition rating is good (7). The roadway consists of chip & seal over HMA pavement and is in good condition. Additionally, there is erosion occurring at the SW corner of the bridge where a drop off of pavement is occurring. Lastly, there is debris in the waterway, so clearing of debris will also be required as part of the project.

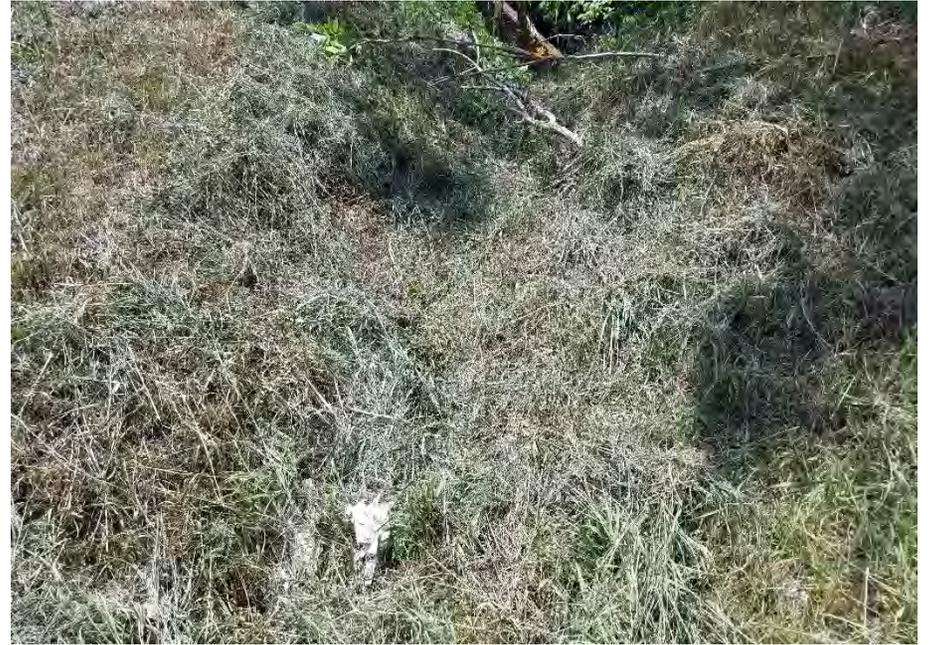
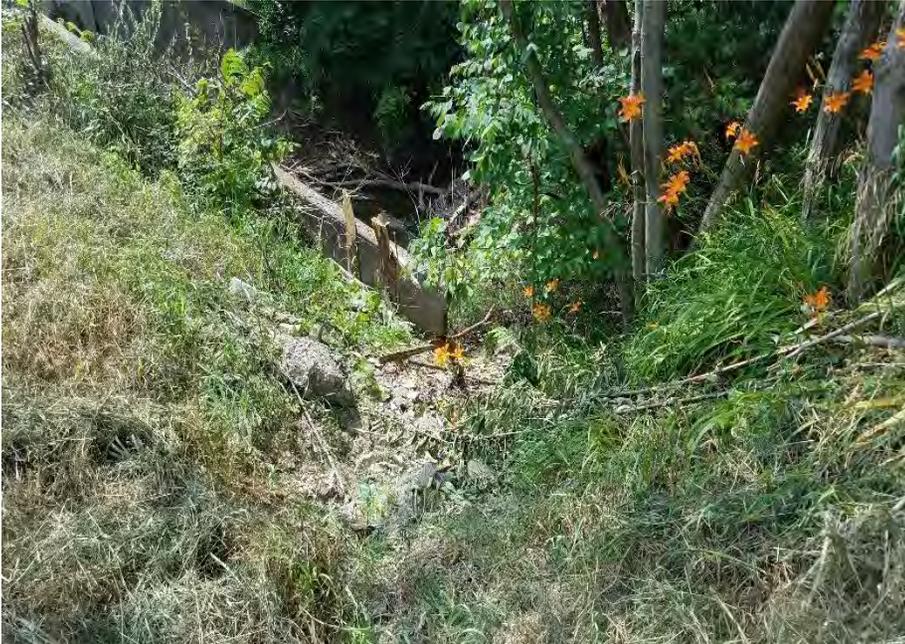
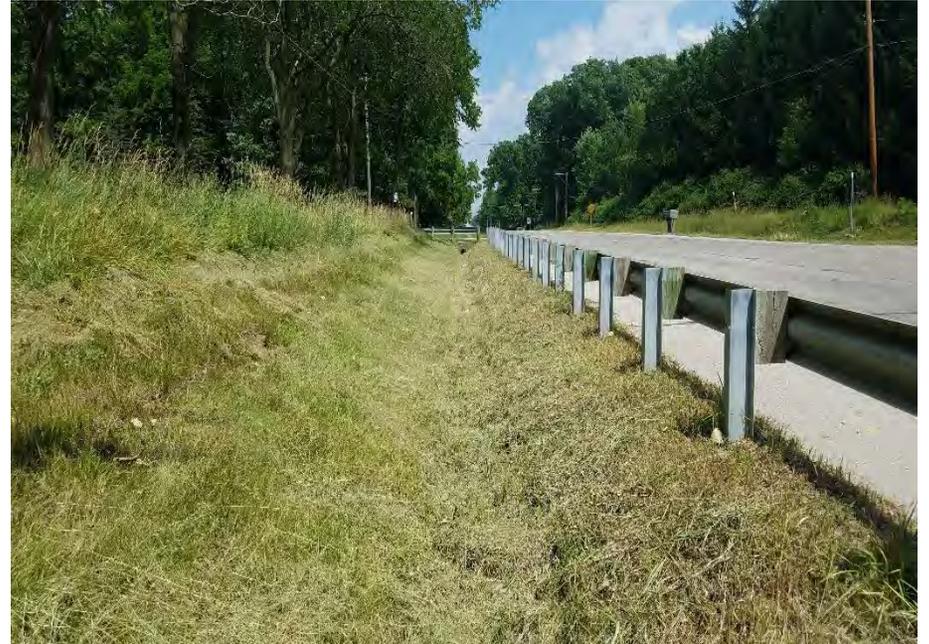
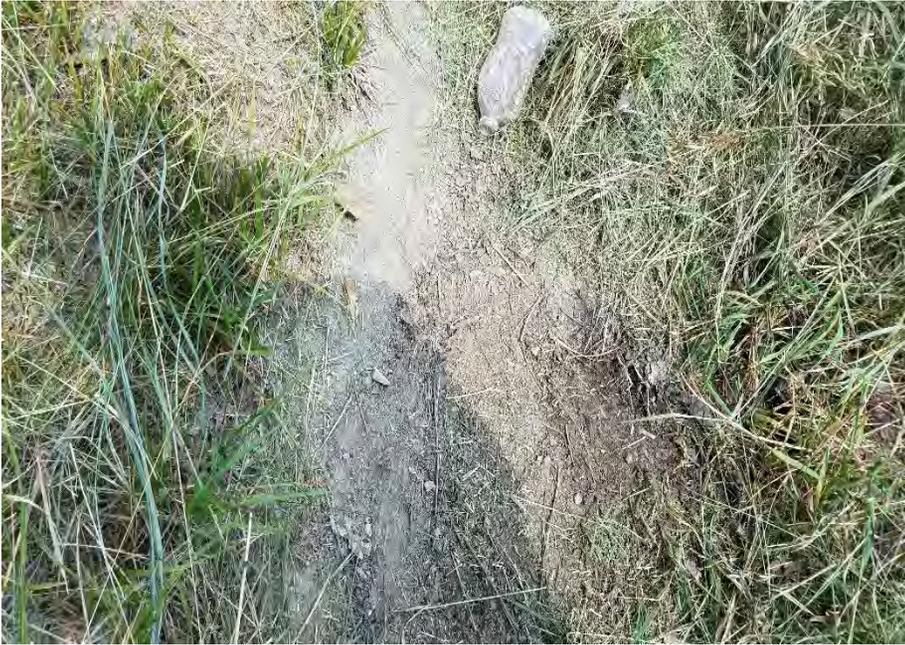
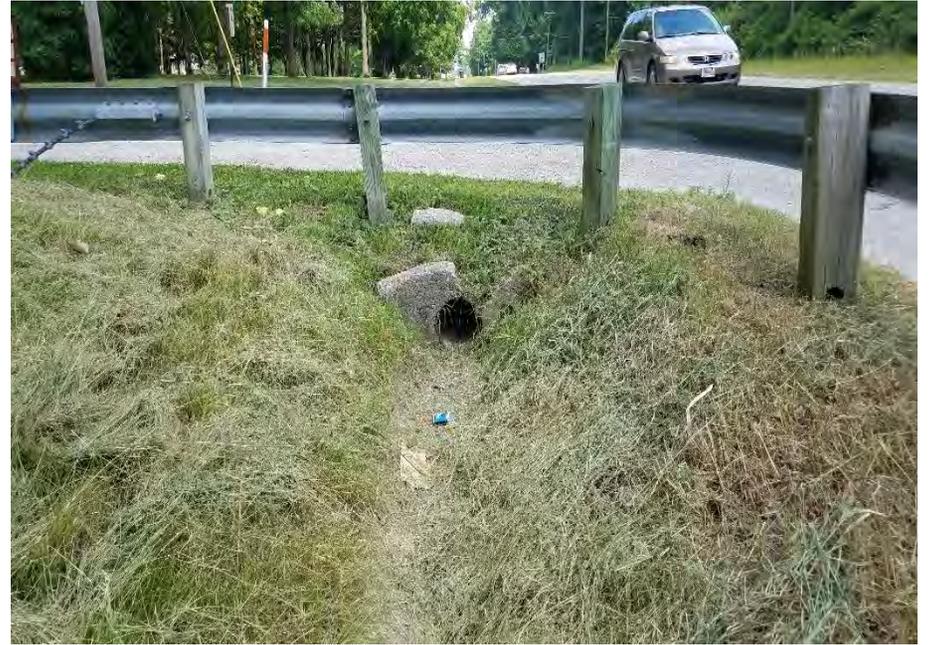
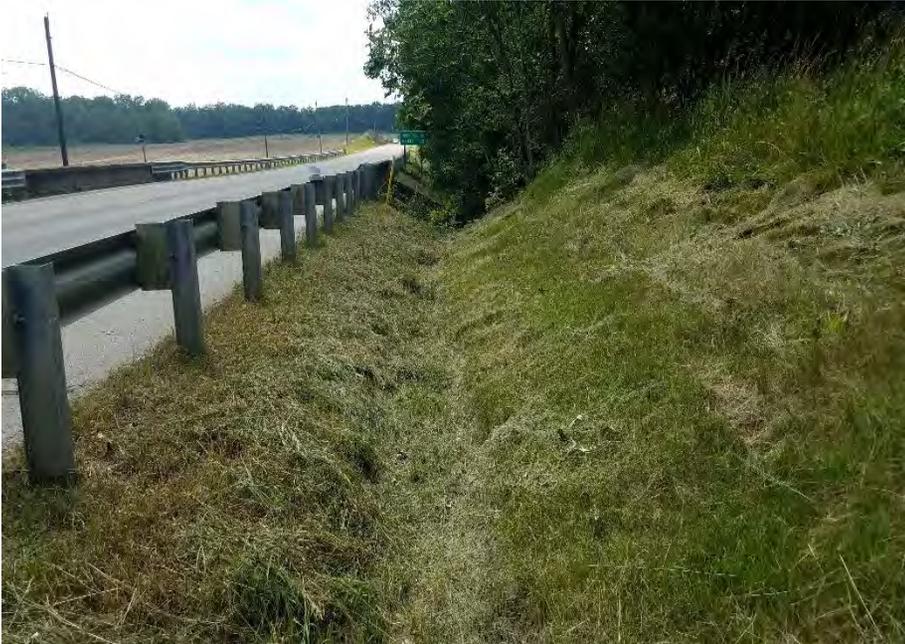
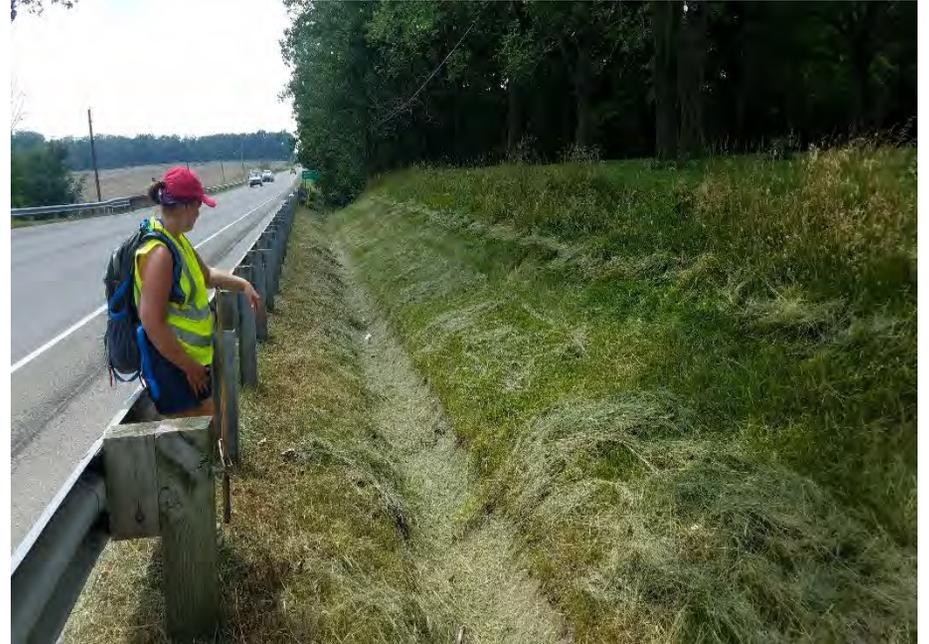
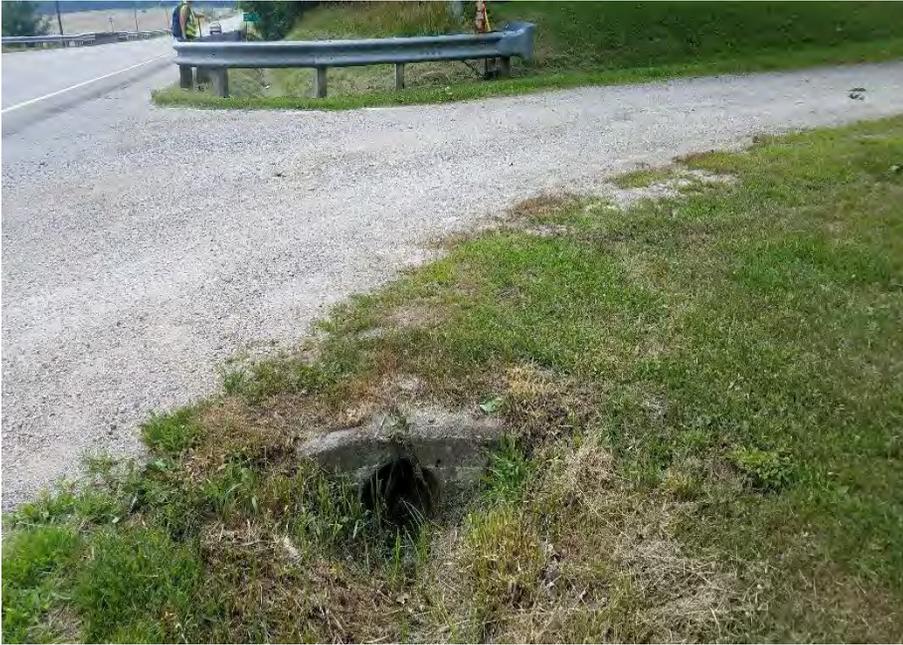
UNT 2 is an ephemeral concrete roadside ditch in the northeast quadrant of the bridge that conveys drainage from east to west towards Holthouse Ditch. UNT 2 is not mapped on the attached NWI map but would have a Cowardin Classification of R4UBHx (Riverine, ephemeral, unconsolidated bottom, excavated). A review of the US Geological Survey (USGS) *Streamstats* application did

not show UNT 2. It is not mapped on the attached topographic map. UNT 2 exhibited an OHWM width of 6 inches and depth of 2 inches. This stream is considered poor quality because it has an artificial substrate, provides no in-stream cover, exhibits low sinuosity, and does not provide riffle and run complexes. This feature is likely jurisdictional under the authority of the USACE because it exhibits an OHWM and drains into Holthouse Ditch, which is a likely jurisdictional water feature. UNT 2 is shown in photos 26 through 33 in the attached photo log.

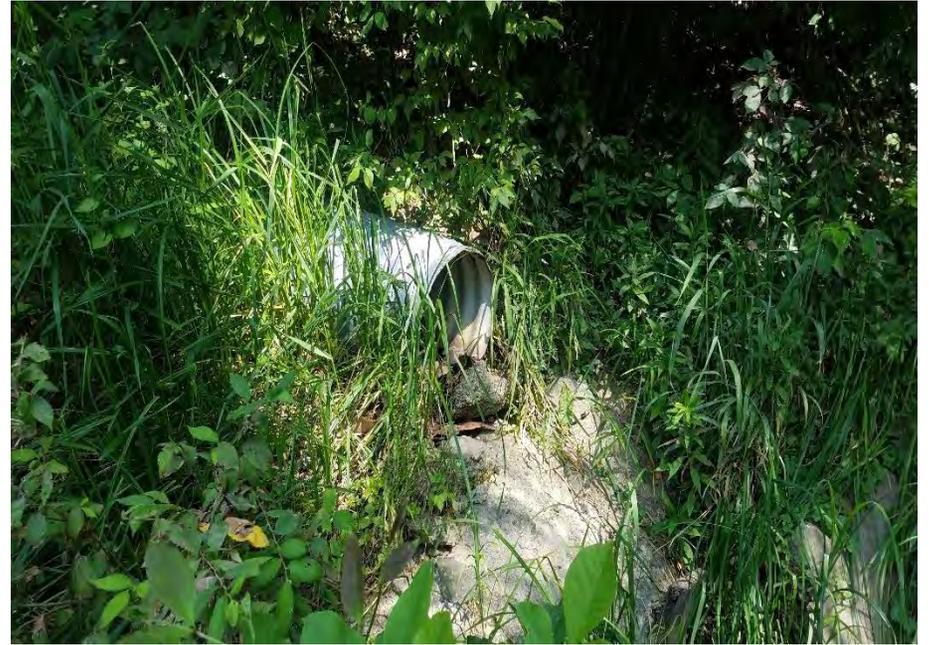
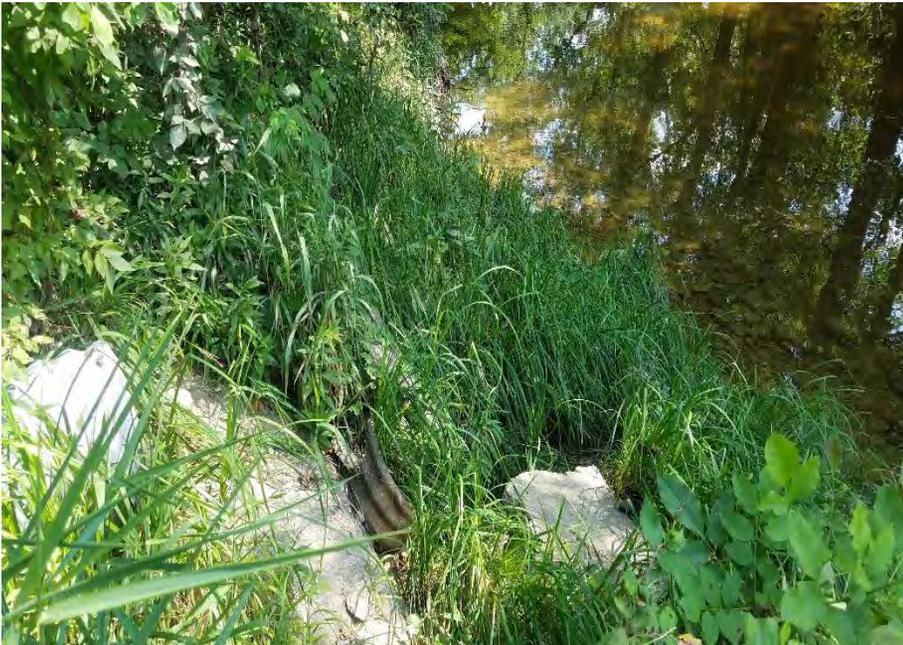
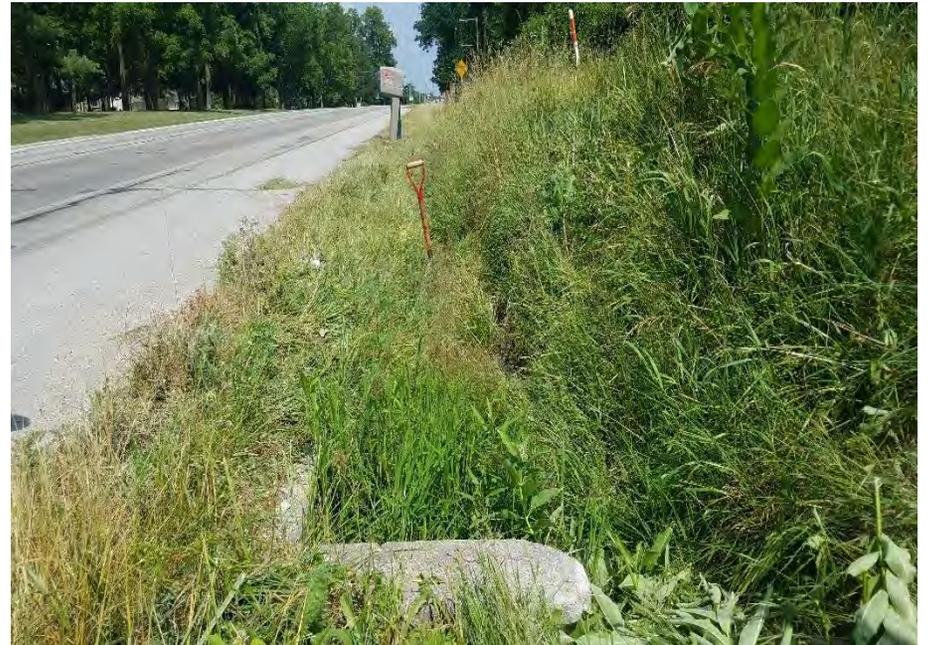
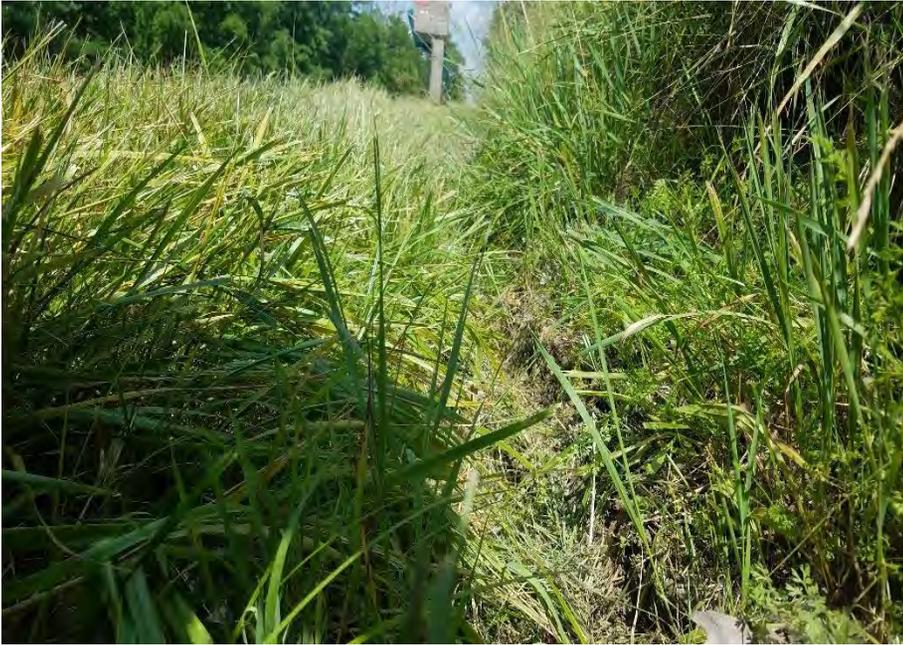
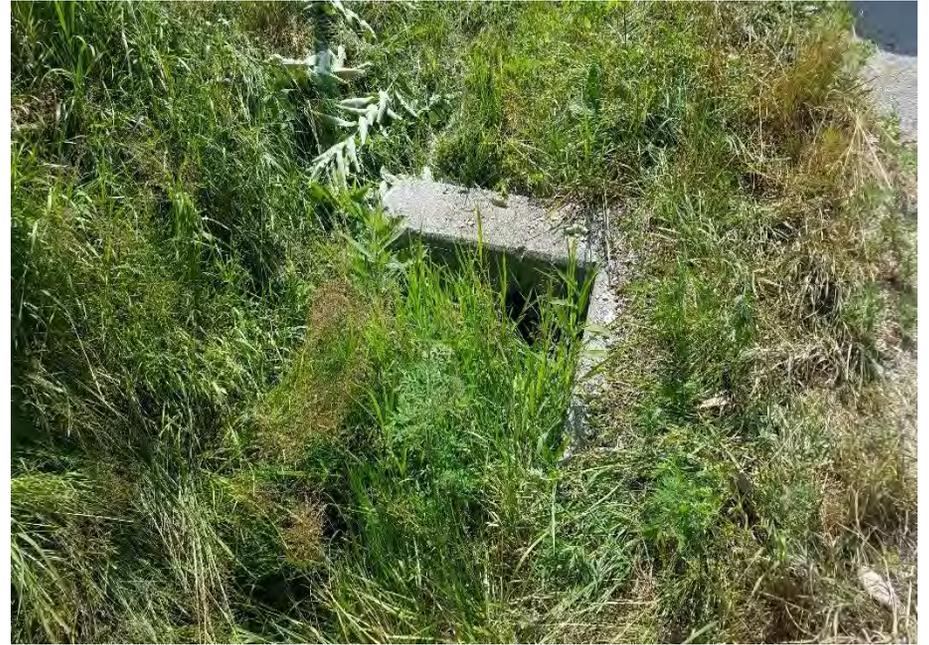
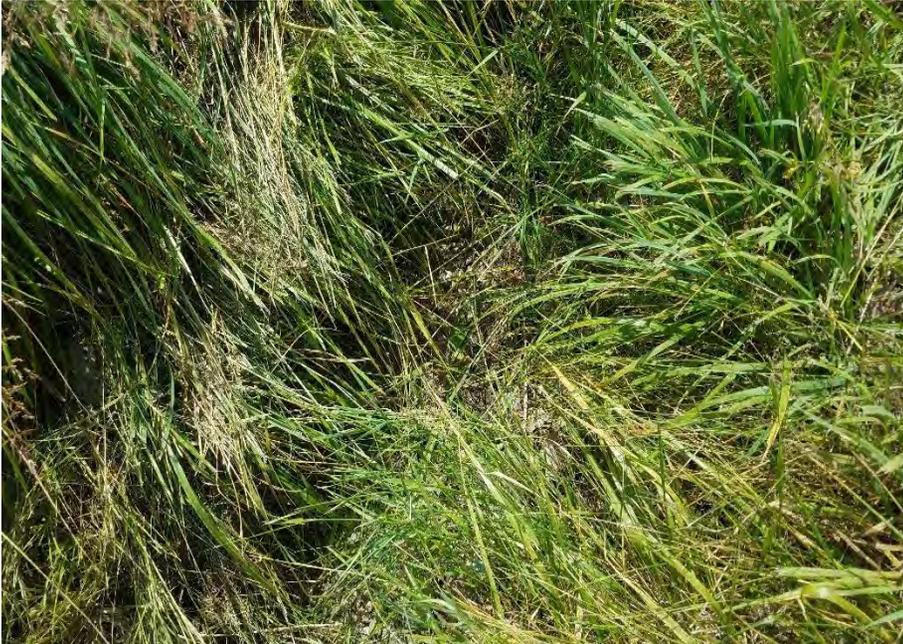
UNT 3 is an ephemeral stream on the southeast quadrant of the bridge that conveys drainage from east to west towards Holthouse Ditch. UNT 3 is not mapped on the attached NWI map but would have a Cowardin Classification of R4UBHx (Riverine, ephemeral, unconsolidated bottom, excavated). A review of the US Geological Survey (USGS) *Streamstats* application did not show UNT 3. It is not mapped on the attached topographic map. UNT 3 exhibited an OHWM width of 6 inches and depth of 2 inches and is carried by a culvert under CR 100 West to outlet into Holthouse Ditch. This stream is considered poor quality because it has a substrate of silt, provides no in-stream cover, exhibits low sinuosity, and does not provide riffle/run complexes. This feature is likely jurisdictional under the authority of the USACE because is exhibits an OHWM and drains into Holthouse Ditch, which is a likely jurisdictional water feature. UNT 3 is shown in photos 34 through 39 in the attached photo log.

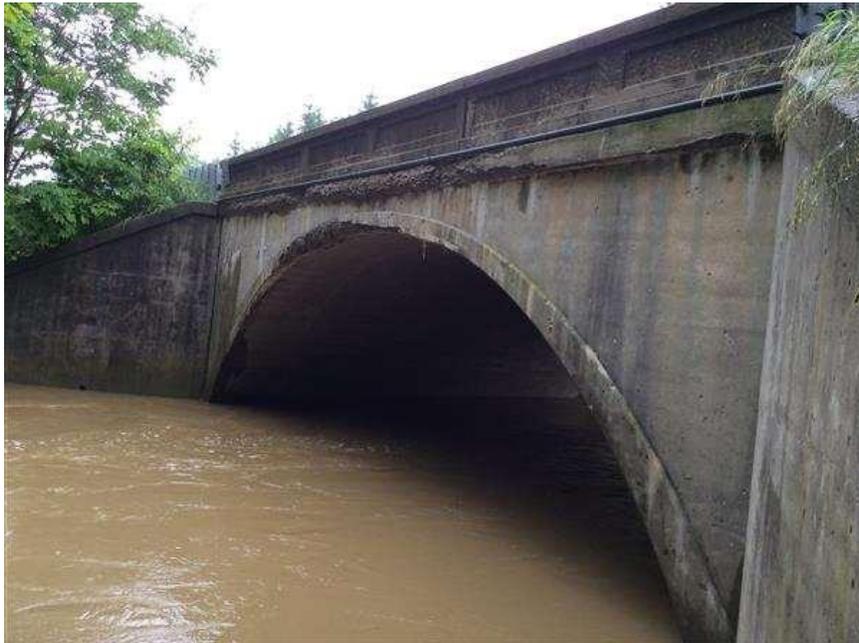
HOLTHOUSE DITCH

(58) DECK: N - Not Applicable	(60) SUBSTRUCTURE: 5 - Fair Condition (minor section loss)
(58.01) WEARING SURFACE: 7 - Good Condition	(61) CHANNEL/CHANNEL PROTECTION: 7 - Bank protection needs minor repairs
(59) SUPERSTRUCTURE: 5 - Fair Condition (minor section loss)	(62) CULVERTS: N - Not Applicable

No "hard" deck. HMA roadway carried over structure on shallow fill. Very soft HMA shoulders next to parapets. Parapets are short in height, original to structure; north wall has tightly spaced map cracking & large area of spalling to lower section. South wall in similar condition with additional spalling to cap.

Arch Ring: south edge has heavy deterioration (spalling with exposed rebar 12' (L) x 1' (W) in top of arch ring with associated map cracking to either end of spalling, all with severe alkali-silica reaction {ASR}); heavy deterioration to center portion of head wall. North edge is similar to south edge, with greater deterioration in head wall; a few hairline parallel (to traffic) cracks; a few hairline, irregular parallel cracks;

Spandrels: decorative caps (below parapets) on both walls are disintegrating; areas of heavy efflorescence from caps; a few cracks with efflorescence;

West Abutment: NW Wing is disintegrating at corner next to spandrel wall (2'); each end of thrust block has heavy efflorescence and ASR; SW Wing in Good Condition; some honeycomb around a couple drains;

East Abutment: SE Wing is disintegrating at corner next to spandrel wall (2'); east thrust block has heavy scaling (below spring line); each end of thrust block has heavy efflorescence and ASR; NE Wing in Good Condition;

Spread footings on clay, with no piling. No riprap protects the foundations or wing walls. West thrust block (and footing) has a small sand bar in front. East thrust block is completely exposed, along with the top portion of the footing.

The purpose of this project is evidenced by the deteriorated condition of the existing superstructure and substructure. The proposed improvement is the replacement of the existing bridge and to widen the typical section by increasing the shoulder to 6-ft paved through the approaches and 8-ft paved through the structure to meet minimum design criteria.
